Manhole Inspection Summary

Manhole # S01UU1006MH

Insp Date: **8/11/06 9:53 AM**

Location Address: **3714 MENLO DR**

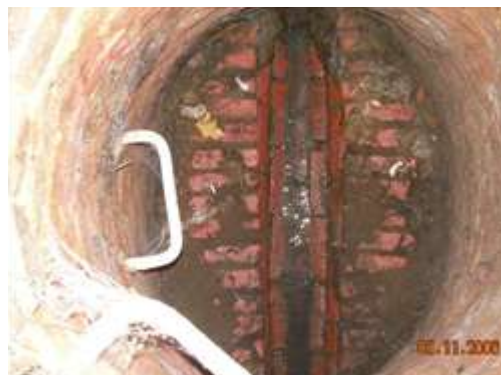
Top View

Condition: ☐ Sound ☐ Cracked ☒ **Root Intrusion** ☐ Loose Brick ☐ Deteriorated

Infiltration: ☐ None ☐ Joint ☐ Cracks ☐ Mortar ☒ **Roots** ☐ Wall

Bench ☒ Exists Material: **Brick** ☐ Parged ☒ **Debris** (not Condition related)

Surcharge ☒ **Evidence Of Surcharge** Depth: **1** (ft.) ☐ Active Surcharge Present

Corbel root intrusion and infiltration.
Evidence of surcharge - Bench debris.

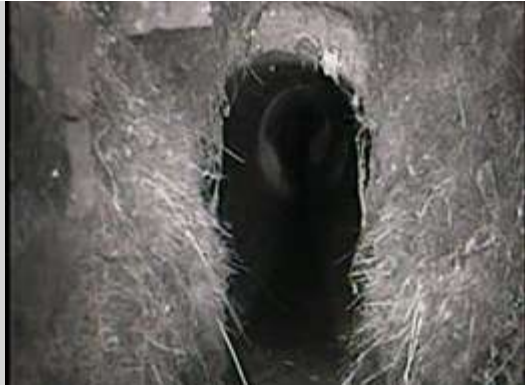
8 in. Circular Gravity Sewer Pipe Out @ 12 O'Clock

Condition: ☐ Sound ☐ Cracked ☒ **Root Intrusion** ☐ Loose Brick ☐ Deteriorated

Condition: ☐ Sound ☐ Cracked ☒ **Root Intrusion** ☐ Deteriorated ☐ Leaks ☐ Debris

Barrel and Channel root intrusion.

Infiltration: **None** Pipe Seal Cond: **Roots**
